BLYNCSY CASE STUDY

**THE CITY OF
PLANO, TEXAS**

The City of Plano, Texas conducted an “apples to apples” comparison of their traditional manual method of surveying four centerline miles of roadway to Blynscsy’s Blynscsy product analyzing the same four miles of roadway. This case study seeks to highlight the results of that comparison.

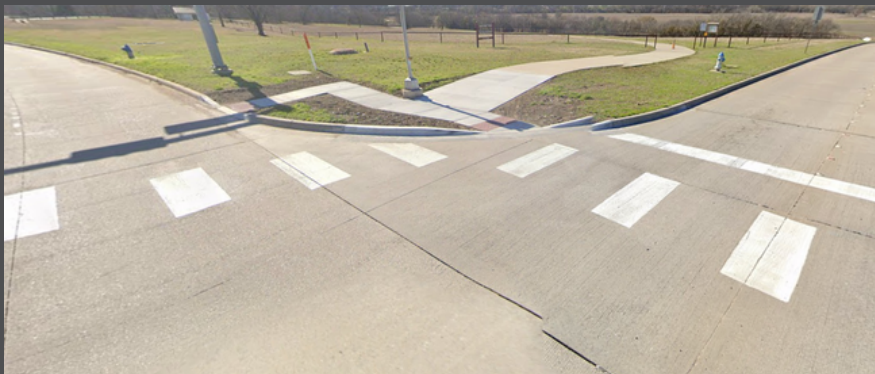
Figure 3. Los Rios Boulevard and Parker Road- The City of Plano Transportation Division identified crosswalk pavement markings that were not aligned with the pedestrian ramp in the northwest corner.

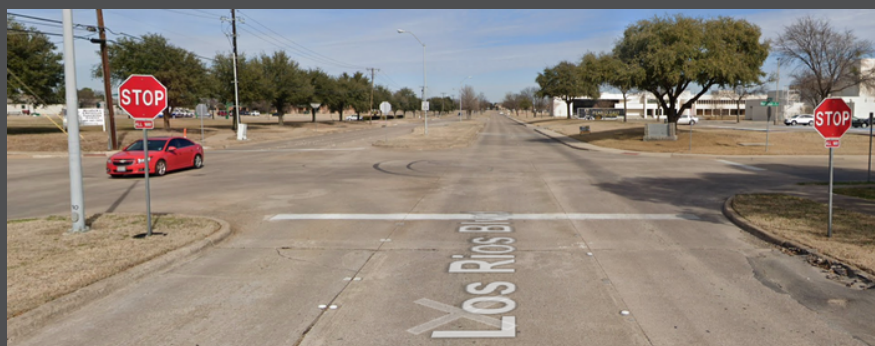
Figure 4. Northbound on Los Rios Boulevard at Merriman Drive- The City of Plano Transportation Division identified that pedestrian ramps were present at all four corners of the intersection, but crosswalk pavement markings were missing at all four approaches.

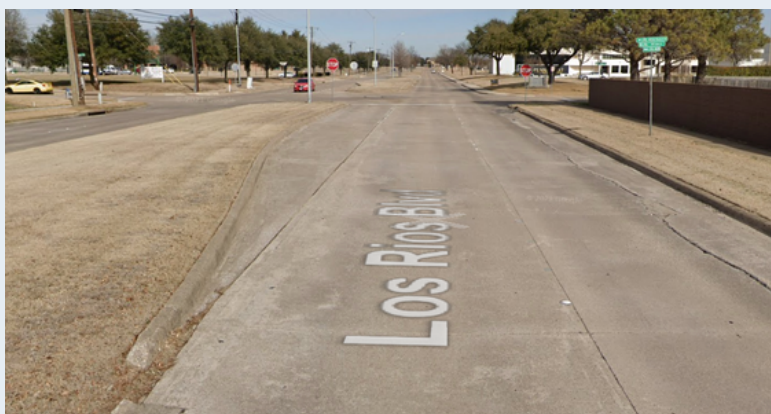
Figure 5. Northbound on Los Rios Boulevard at Merriman Drive- The City of Plano Transportation Division identified missing advanced warning Stop Ahead (W3-1) signs at all four approaches. Per MUTCD Table 2C-4 for a 35 mph condition, the Stop Ahead (W3-1) sign shall be placed 100 feet in advance of the Stop (R1-1) sign.

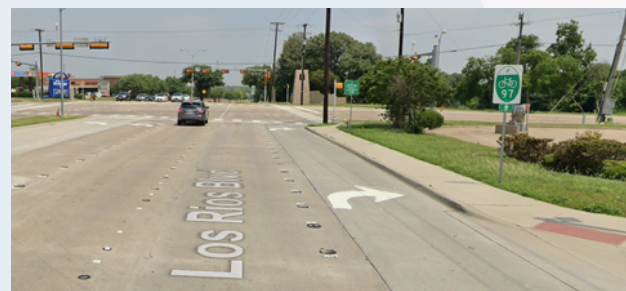
Figure: 6. Los Rios Boulevard and 14th Street- The City of Plano Transportation Division identified missing mandatory movement lane control signs, i.e. Right Lane Must Turn Right (R3-7) and Right Turn Only (R3-5) signs.

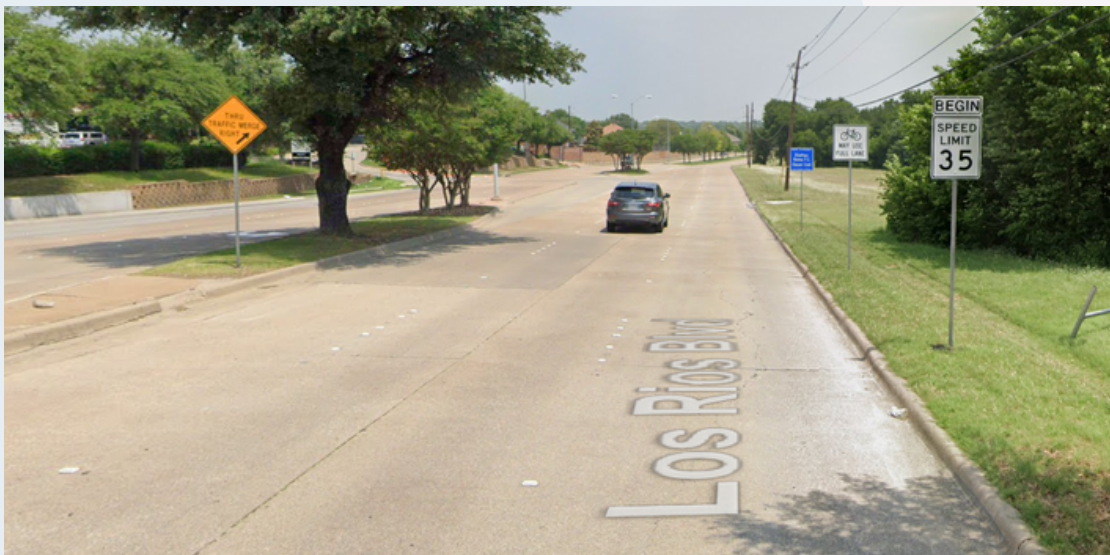
Figure 7. Northbound Los Rios Boulevard at 14th Street- The City of Plano Transportation Division identified insufficient and incorrect use of signs and pavement markings in order for drivers to taper and merge properly for the inside lane drop traveling northbound on Los Rios Boulevard north of 14th Street.

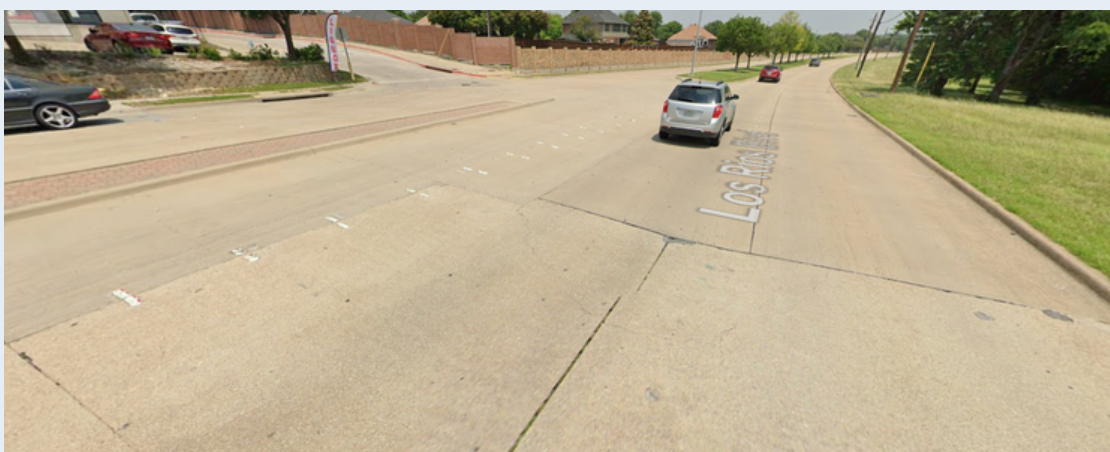
Figure 8. Abrupt lane drop traveling northbound on Los Rios Boulevard at 14th Street

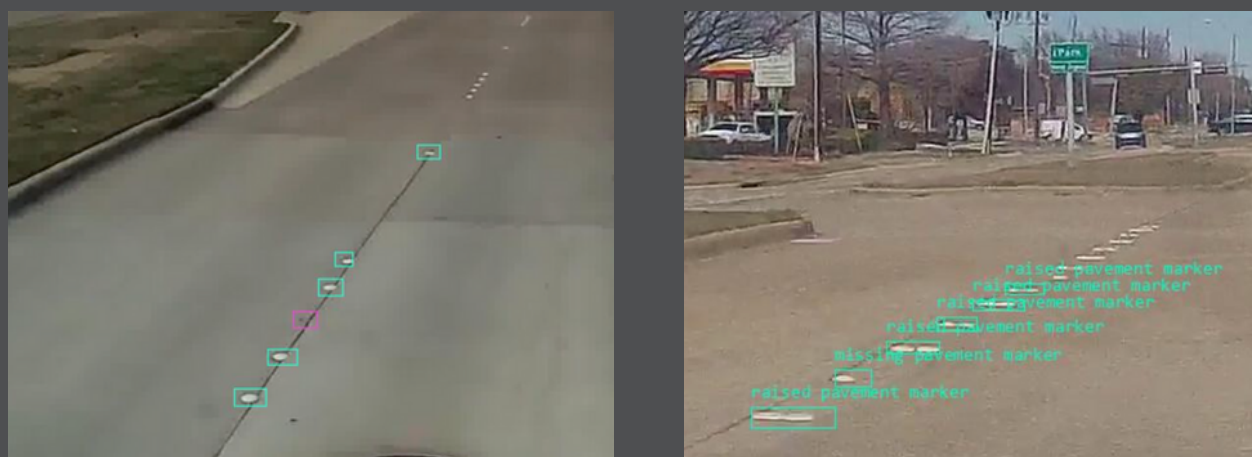
Throughout this project, Blynscsy detected a total of 9,539 raised pavement markings and detected 242 missing pavement markings. These missing pavement markings were located within groupings of 5, which means that the line lane is still considered in good condition.

Figure 13. This figure shows two different examples of missing raised pavement markings

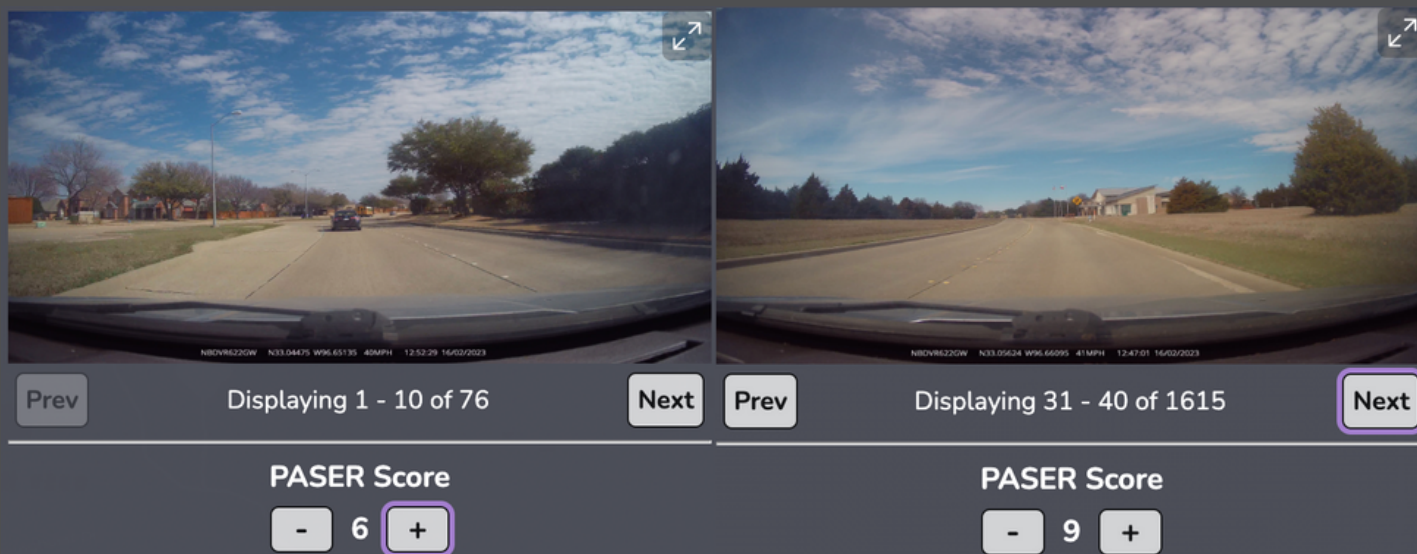
Figure 17. A segment with a score of 6 is shown on the left and a segment with a score of 9 is shown on the right

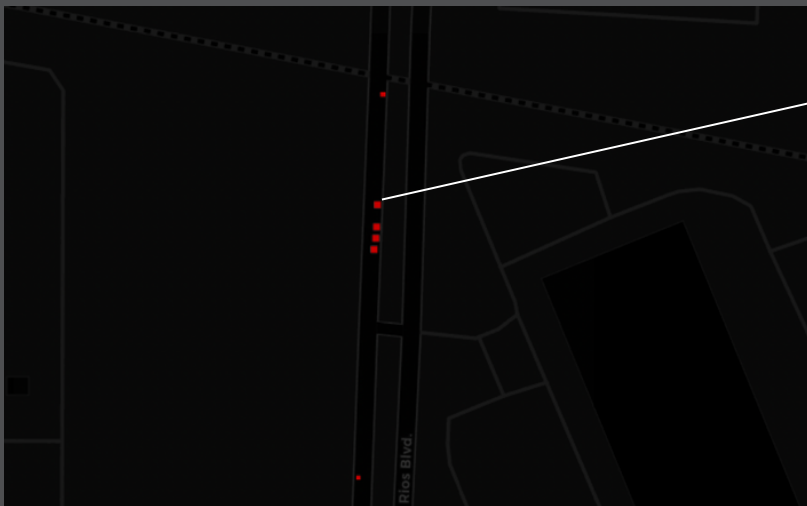
Figure 19. This figure shows the images with vegetation encroachment were located relatively close to each other

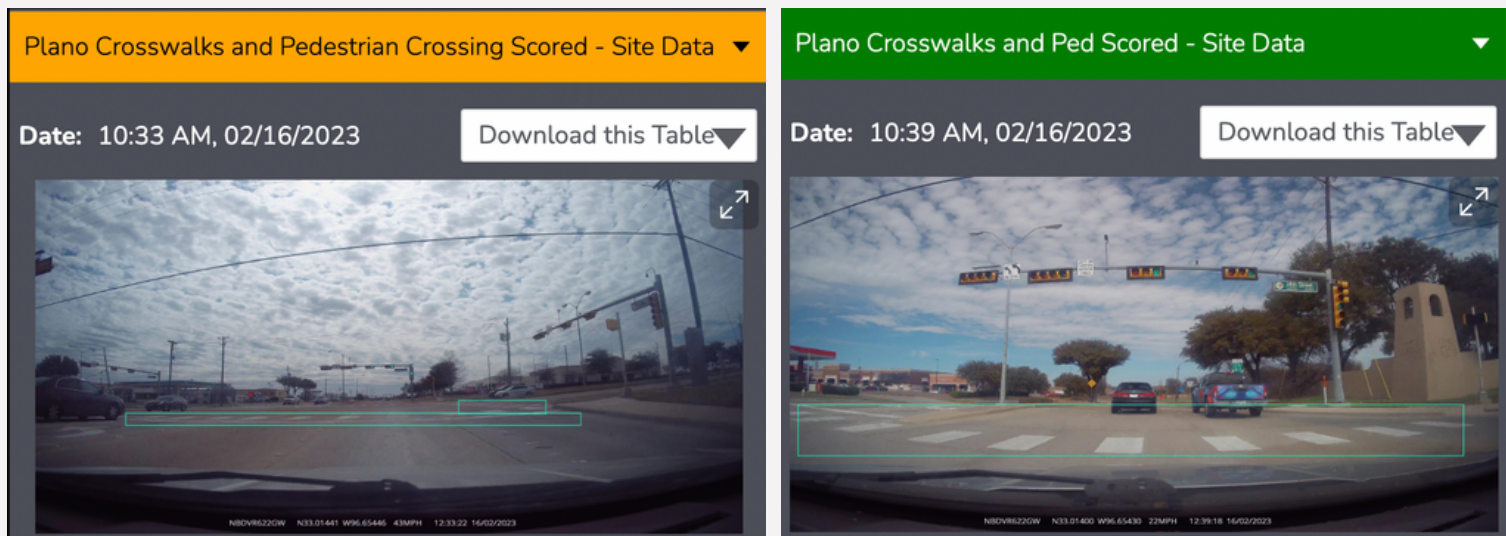
Figure 25. A fading crosswalk scored as 3 is shown to the left and a visible crosswalk scored as a 0 is shown to the right

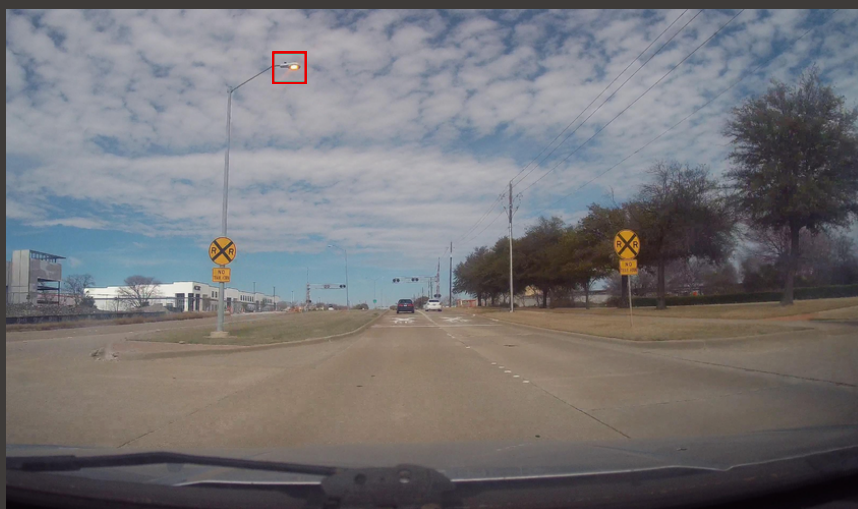
In Blynscsy's four mile survey, it detected one streetlight that was on during the day located near the intersection of Los Rios Boulevard and Plano Parkway. Blynscsy detected 18 different images of this individual streetlight from different angles and approaches.

Figure 29. Blynscsy detected this streetlight that was on during the day

The City of Plano did not evaluate this condition in their manual survey. Since Plano does not maintain the city's streetlights, this is not a major concern for the city. However, using Blynscsy's data, they were able to notify their streetlight management company using their streetlight outage system.

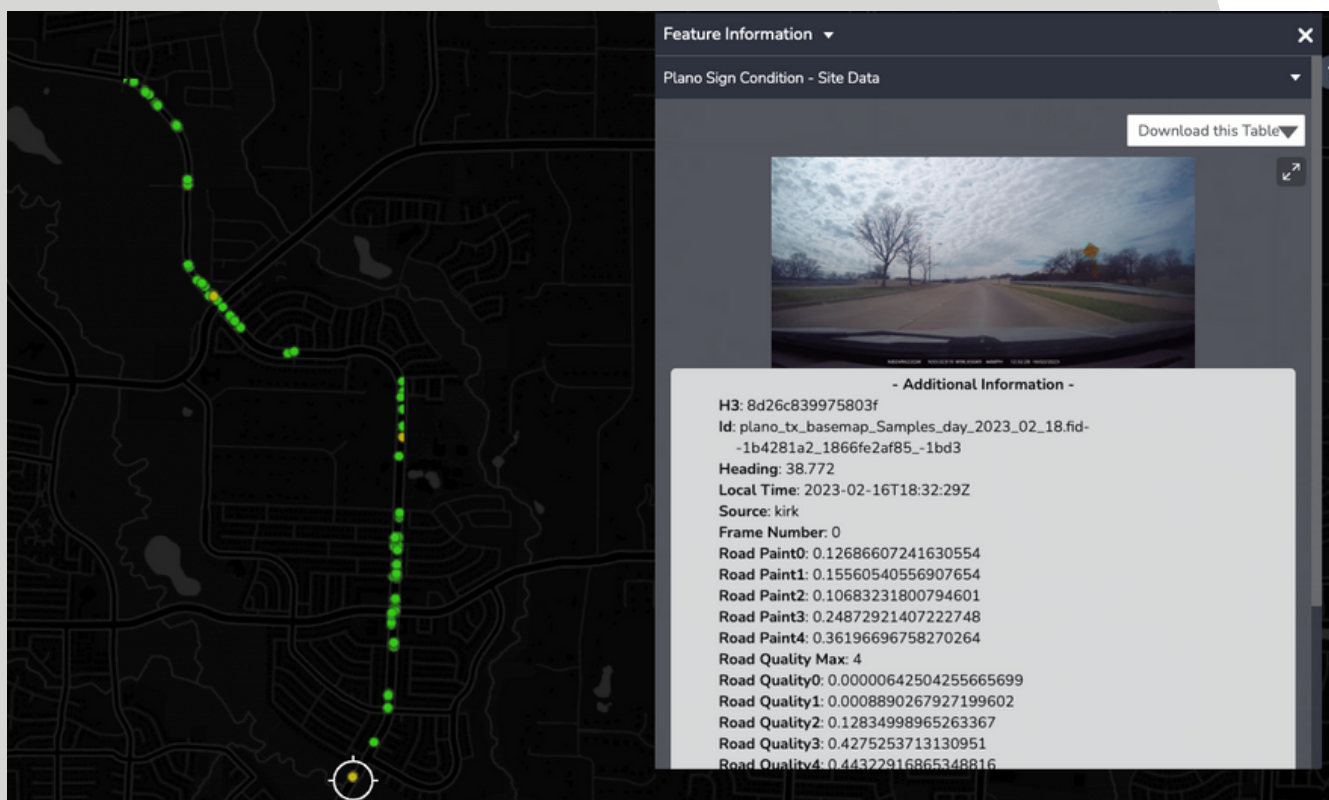
Of the 143 signs that BlynCSY detected, only eight were in fair condition and zero were in poor condition

Figure 37. BlynCSY color codes signs based on their condition and displays this data on a GIS map
